Shell Ship Quality Assurance - Safety Flash

Incident Type: Main Engine Start Failure Additional: Failure after fuel changeover

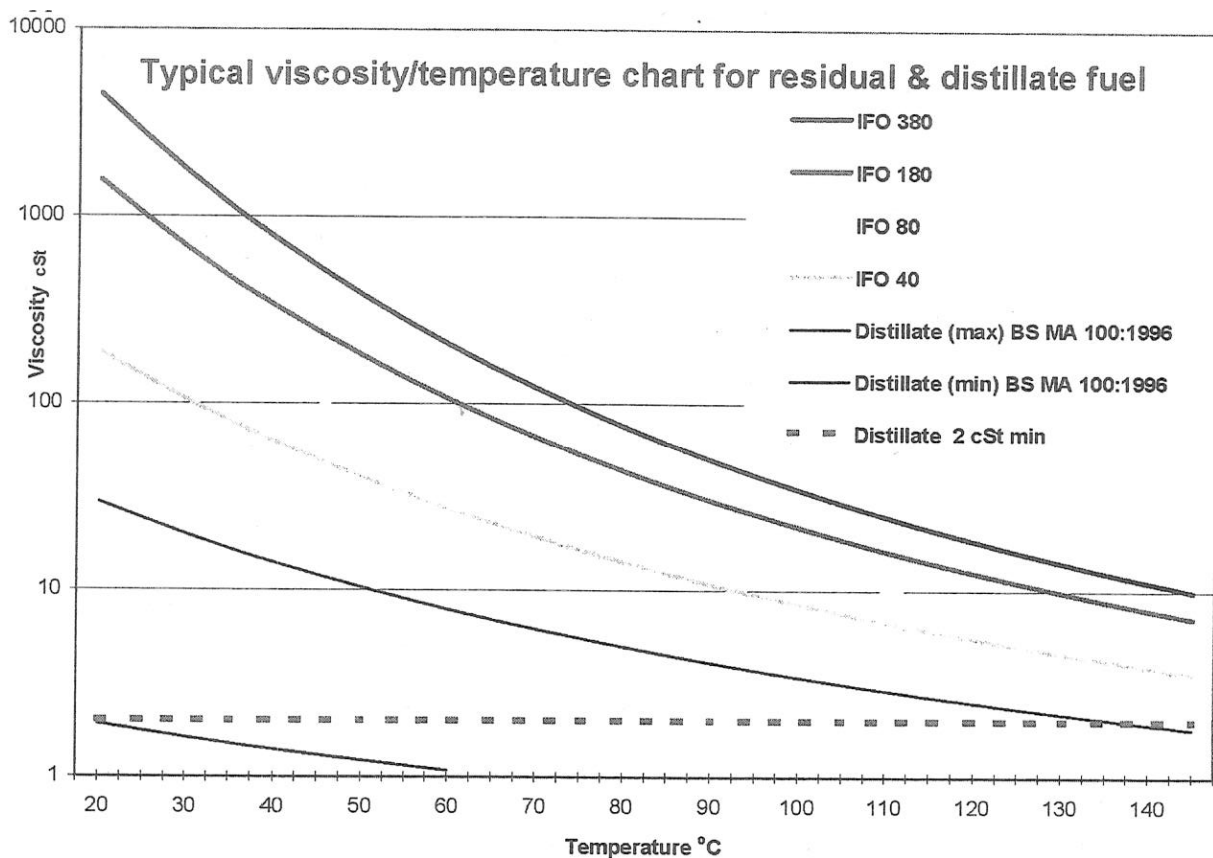
Further the guidance from this manufacturer is that the lowest viscosity suitable for most two-stroke diesel engines is 2.0 cSt at the engine inlet. It is to be noted that MGO with a minimum viscosity of 1.5 cSt at 40 deg C (ISO 8217) requires approximately 22 deg C to keep the limit to 2.0 cSt. The manufacturer further advice that maintaining the fuel oil temperature in the required range may require installing a cooler together with appropriate controls in the design of the modified fuel oil system.

For the lowest viscosity MGOs, the manufacturer advice that a cooler may not be sufficient and that in such cases it may be necessary to include in the design a so-called "Chiller" (along with appropriate controls), which removes heat through vapour-compression or an absorption refrigeration cycle.
