Technical eNewsletter

Change-over to low sulphur fuel – a practical example to consider

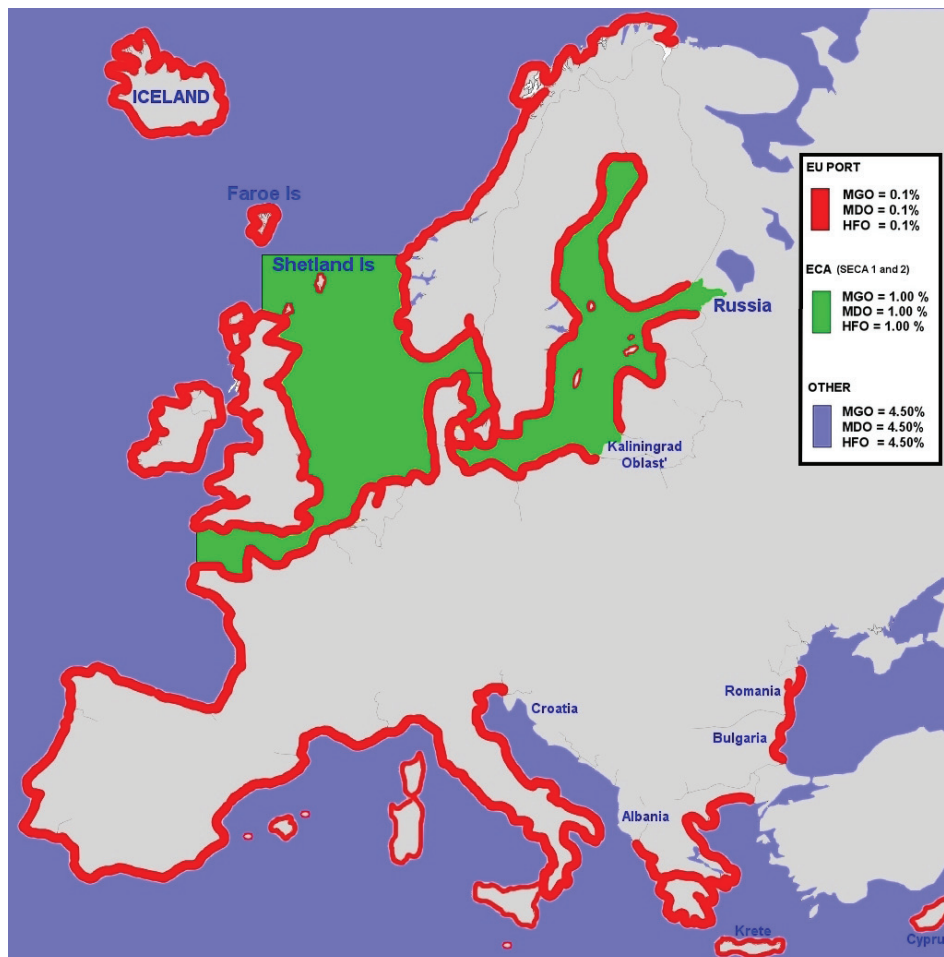
When dealing with change-over procedures, it is imperative to realise that many fuel supply systems are closed-loop systems in which the fuel is continuously circulated.

When changing over from HFO (Heavy Fuel Oil) service tanks to LSF service tanks, there will be no immediate change of supply to the consumers (engines, boilers), only a dilution of the fuel circulating in the supply system.

Consequently, the change-over time will be governed by the fuel oil consumption. Due to the relatively large quantities of fuel circulating, the time needed to complete the change-over can be relatively long. With only the main engine running, the blending-in ratio may be in the region of 1% per two minutes, and with only one auxiliary boiler or one auxiliary engine in operation the ratio can be much lower.

Experience has shown that in some cases fuel change-over is not complete even after 48 hours. As a result, the sulphur content of the fuel consumed may be in excess of the applicable sulphur content limits.

It is highly recommended that sufficient time be allowed for the fuel change-over before entering an area in which limitations to the sulphur content apply.

This can be verified by testing fuel quality vs. time during change-over. Depending on outcome it may be necessary to install/retrofit separate service tanks and pipelines for HFO and MGO to auxiliary engines and boilers to achieve a satisfactory change-over time and result.
